***Evaluative Testing of the Bent Canyon Stage Station  
on the Piñon Canyon Maneuver Site,  
Las Animas County, Colorado***

**Fort Carson Cultural Resources Management Series Contribution Number 13**

**Minette C. Church and Pamela Cowen**

**2005**

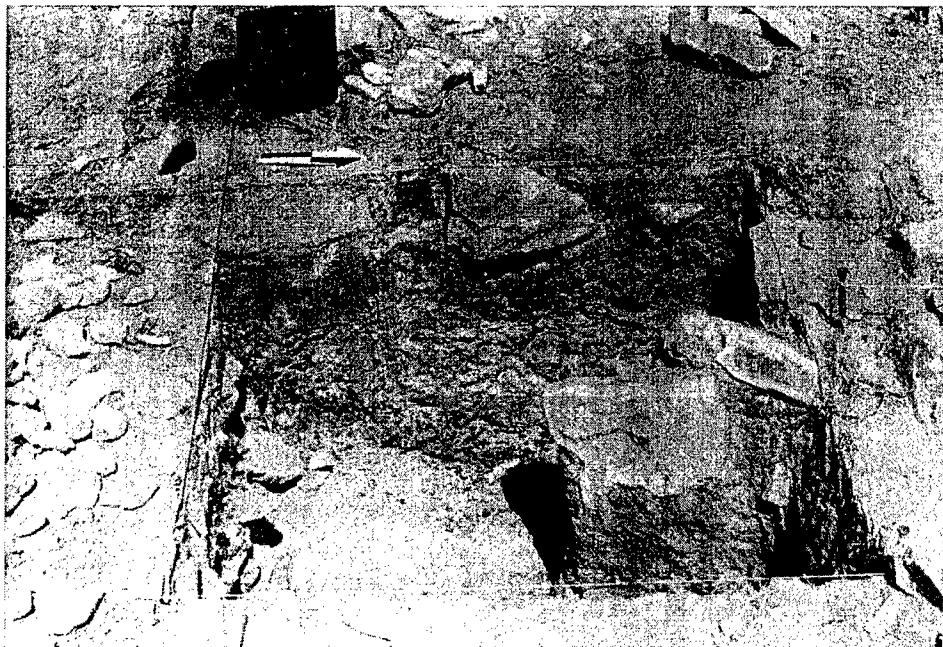
Figure 54: Feature 13, Unit 26 - post-occupation pit displacing southeast foundation corner of Feature 1, Room C

Feature 13 was located in EU 26. The feature was defined as a post-occupational pit located on the southeast corner of Feature 1, Room C. Unit 26 was placed over the southeast corner of the southernmost room in Feature 1, because that corner of the foundation seemed to be missing. The fact that the foundation had been disturbed in order to excavate a pit after site abandonment became clear in Lot 7, where there was a layer of small rocks. Cut sandstone rocks, apparently from the structure wall, but well below the extant wall, and at odd orientations, occurred at this level. A burned tree root extended under the foundation, and one early hypothesis for that was that when the tree burned and fell, its roots dislodged the stones in the foundation. However, the later exposure of the depth of the pit below this charred root suggests that the feature is in fact one of at least three, if not four, looter pits excavated in this structure, post-occupation. These pits may be associated with rumors of gold having been buried here (Robert Hill, personal communication, August 2000, see also chapter 5). If Feature 1 does represent a general store as well as a Post Office, which fits the evidence, it would not be hard to see how such a rumor might start.
